MNM Fatal 2005-14

- Machinery
- June 17, 2005 (Washington)
- Sand & Gravel Operation
- Operating Engineer/Mechanic
- 32 years old
- Five years mining experience

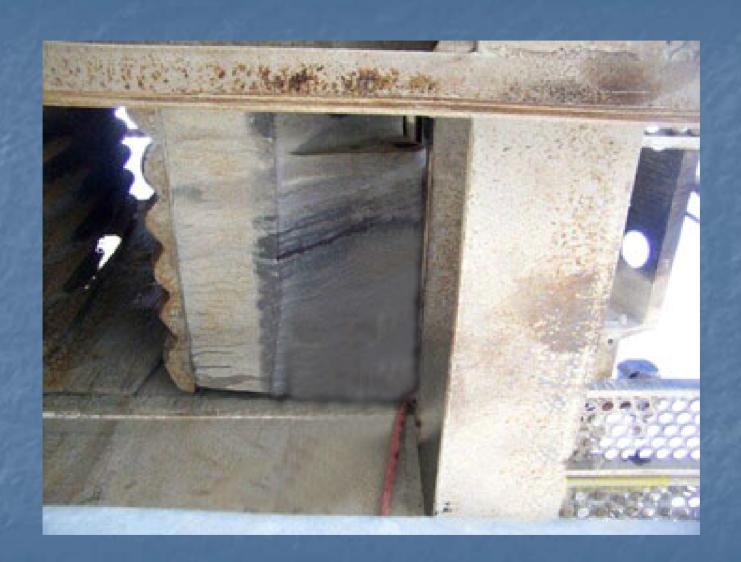
The victim was removing the toggle plate seat from the pitman on a jaw crusher. He was standing on a temporary platform when the bolts holding the toggle seat were removed, causing the pitman to move and strike him.

- Management policies, standards, and controls were inadequate. Procedures were not in place to ensure that the pitman was blocked against hazardous motion before the toggle seat wedge bolts were removed.
- Standards and controls were inadequate. No task training was provided to the miners regarding the removal of the toggle seat on the jaw crusher to make them aware of the health and safety aspects of the task.

- Ensure that miners receive task training prior to allowing them to perform maintenance or repair on machinery or equipment.
- Discuss the work procedures, including all possible hazards (Risk Assessment) and ensure the manufacturer's recommendations are followed for all repair work.

- Before working on equipment, lock out the power and block equipment components against all possible motion/movement resulting from a sudden release of energy.
- If potential hazards or prescribed procedures are unclear, DO NOT proceed until all safety concerns are adequately resolved.
